REFRIGERATOR CARBON STEEL CORROSION ANALYSIS

Investigating Polymer Coating Breakdown and Moisture Effects

Himanshu Prasad

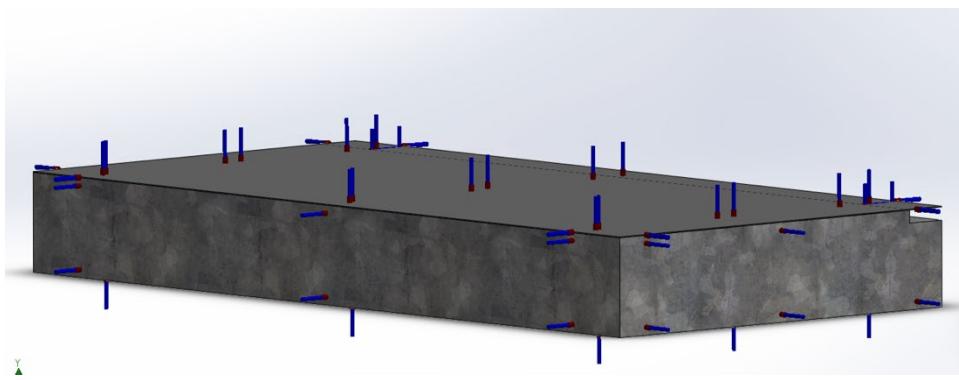
Figure 4. Thermal analysis setup showing the applied uniform temperature load and bonded contact conditions between the polymer coating and galvanized steel substrate.

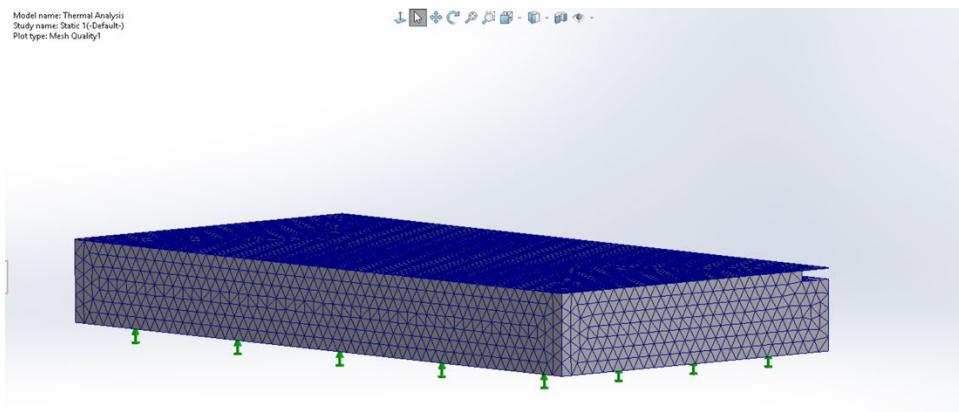
Figure 5. Static study setup with refined mesh and fixed constraint applied to the rear steel face to simulate attachment to the refrigerator structure.

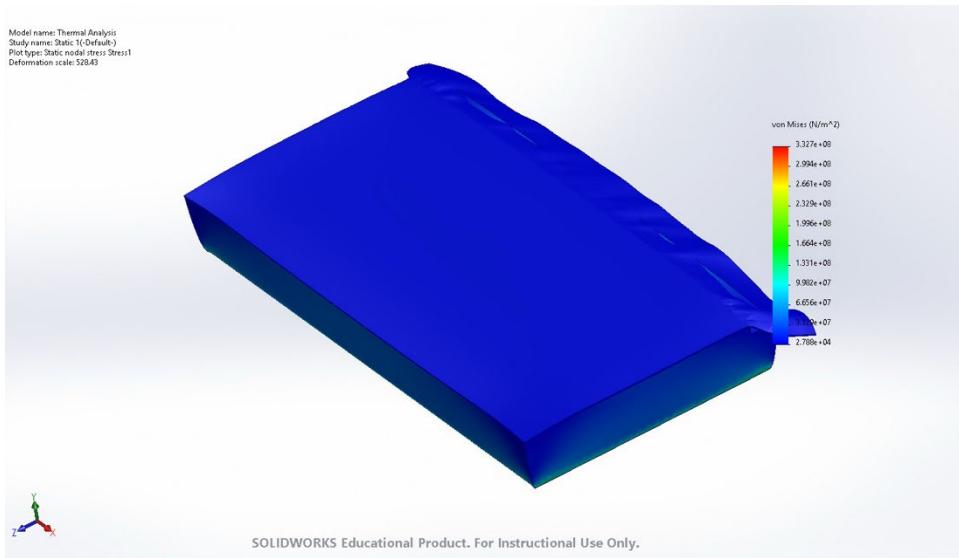
The results showed a strong localization of thermal strain at the seam where the coating transitions over the raised edge. The measured strain values were significantly larger than in the flat region, consistent with polymer expansion being constrained by the metal and the geometry. The elevated strains can model tensile and shear stresses at the interface and are sufficient to initiate adhesion loss. Figures 6 and 7 show the deformed material after the simulation, with the polymeric coating elongated following temperature cycling. Once the adhesion is compromised, moisture can penetrate the gap, which dissolves the underlying zinc coating, and initiate under-film corrosion.

Figure 6. Von Mises stress distribution resulting from differential thermal expansion between the polymer coating and steel substrate.

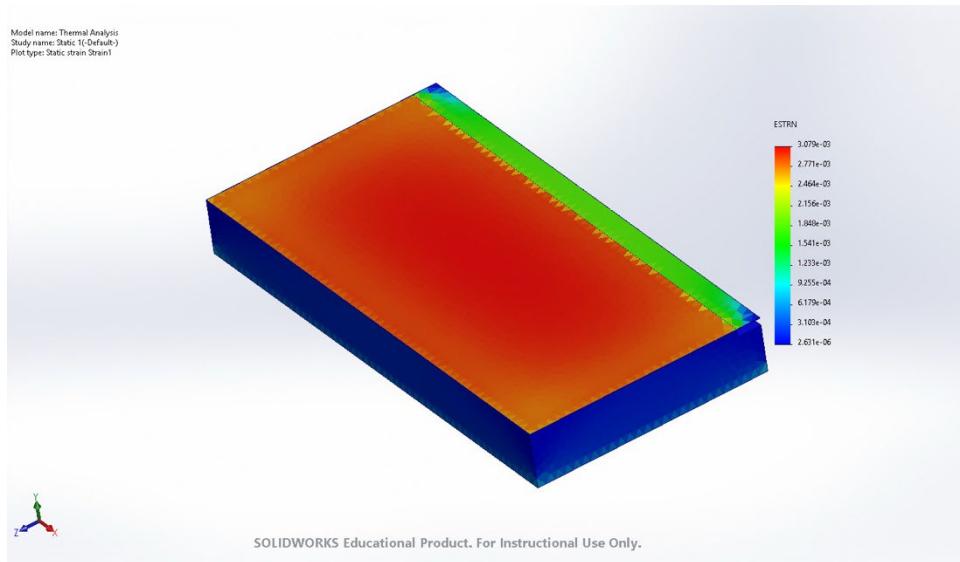
Figure 7. Thermal strain distribution showing high strain localization at the seam and coating edge.

- Design improvements: add slope or drainage paths near the dispenser and incorporate a hydrophobic gasket or sealant to the capillary path at the seam.

- Manufacturing controls: Improve surface pre-treatment and ensure minimum coating thickness and edge sealing around the dispenser assembly.
- User maintenance: Encourage users to periodically wipe and dry the area under the tray to avoid long-term moisture exposure.
